Hama uRage Mobile Gaming Mouse Right click microswitch Replacement

Hama urage double click problem

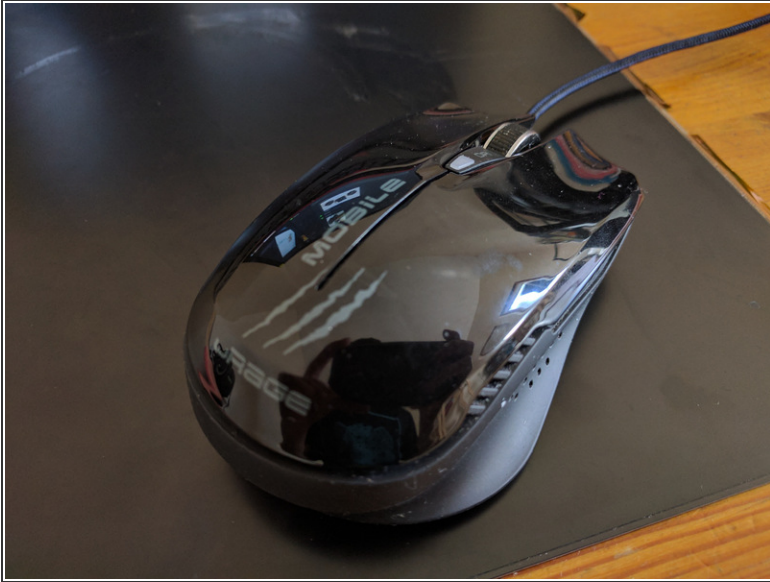
Step 8

- Put the mouse together and test it first before replacing the label and teflon sliders
- Additionally if you want to make the job look professional you can replace the double sided tape and teflon sliders with a new ones, but cleaning old one off and using some superglue may do the trick
- Using the opportunity of opening the case ie you can also give it a clean, the best cleaning solution might be IPA
- The possible cause of this double click problem is probably used up connector inside of the microswitch or bend copper plate if someone used too much force on it, it might be possible to fix it by bending and cleaning it but there would be a risk that it will happen again shortly, it is better to replace it - it is also quicker
